FINAL
PHASE I ENVIRONMENTAL BASELINE SURVEY
THE LANDINGS AT NELLIS HOUSING AREA, PARCEL H
NELLIS AIR FORCE BASE, NEVADA

JUNE 2011

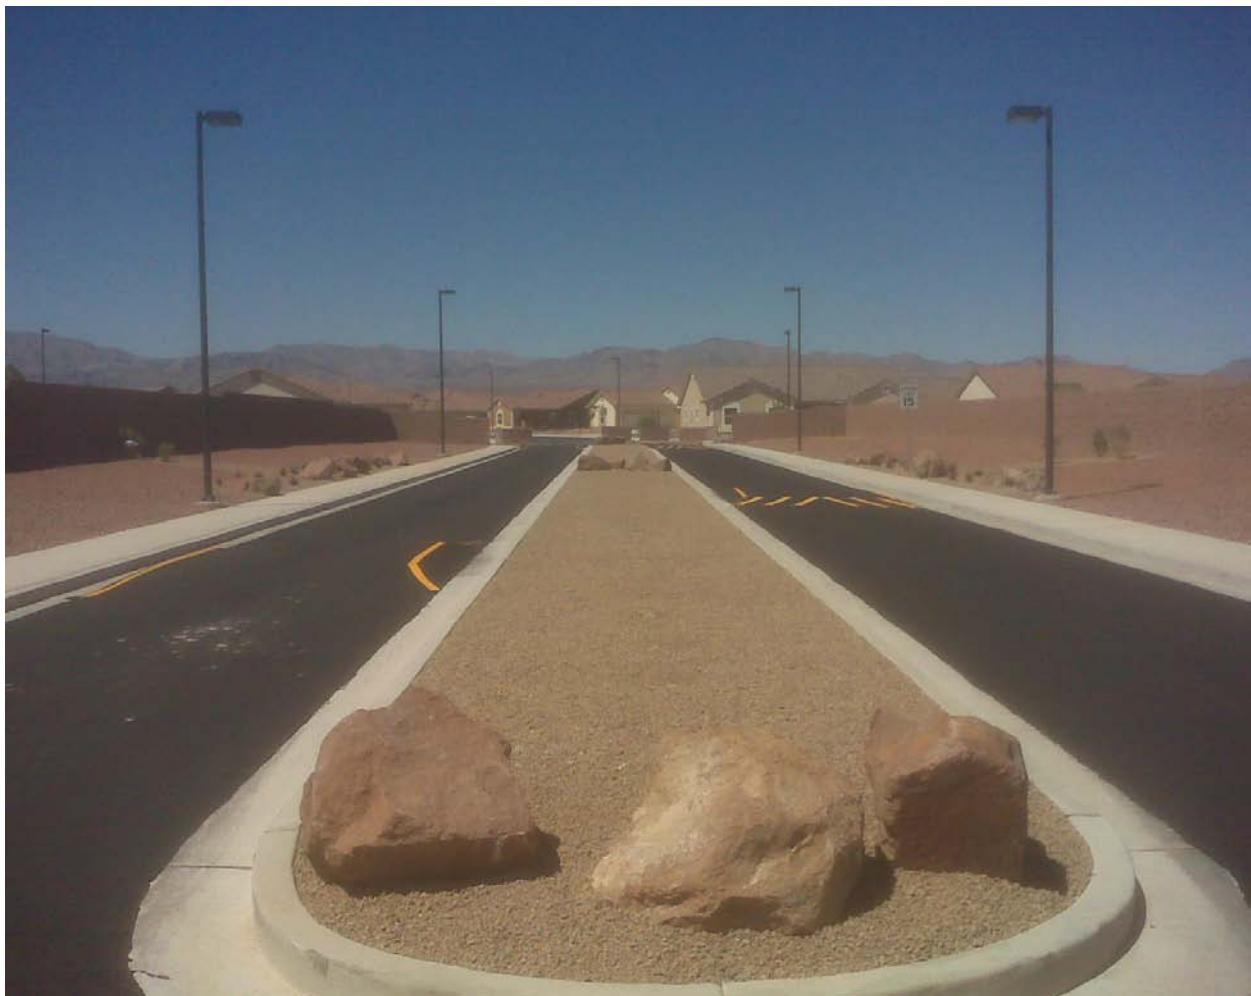
Figure 7, Parcel H looking north from Guard House

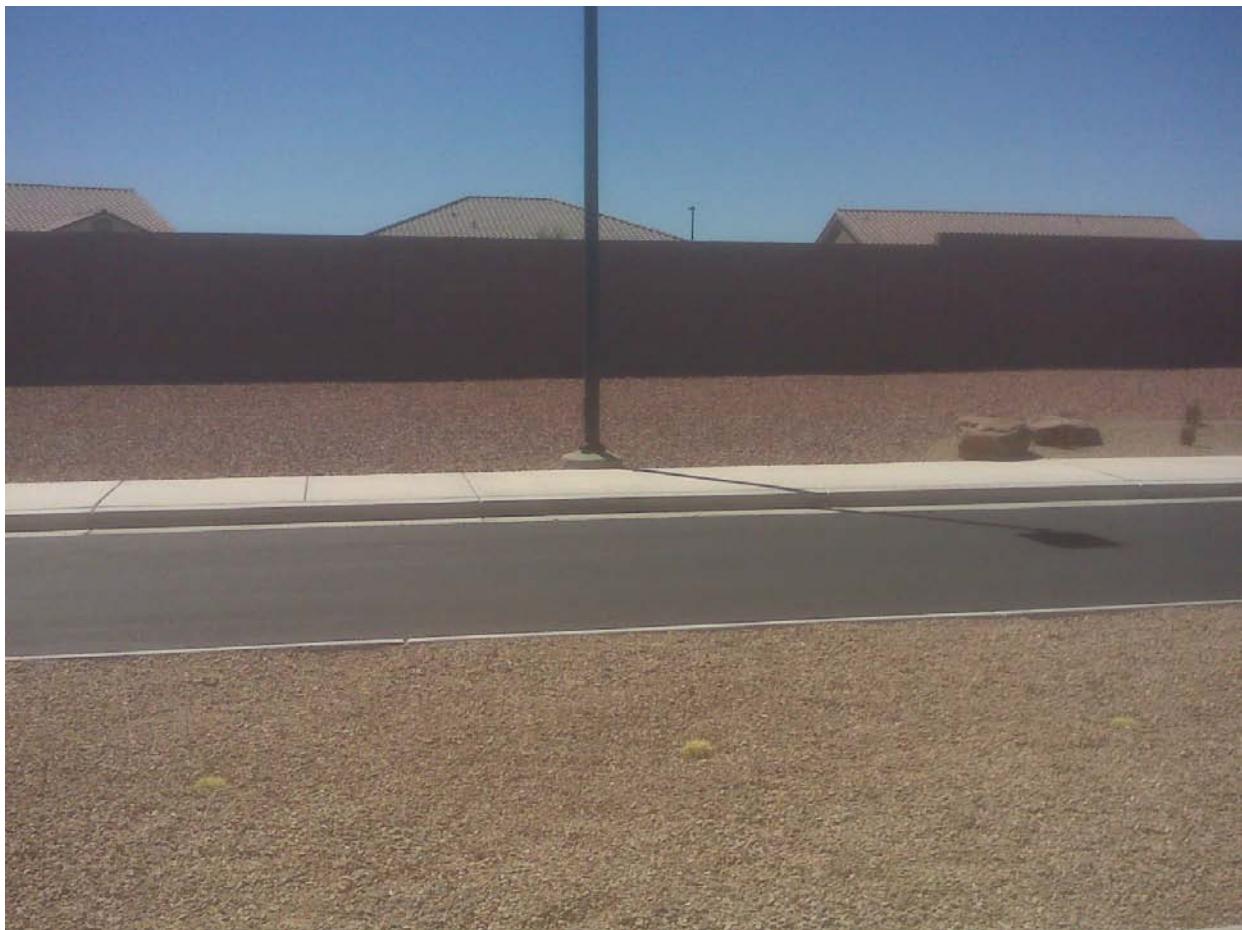
Figure 8, Parcel H east looking west

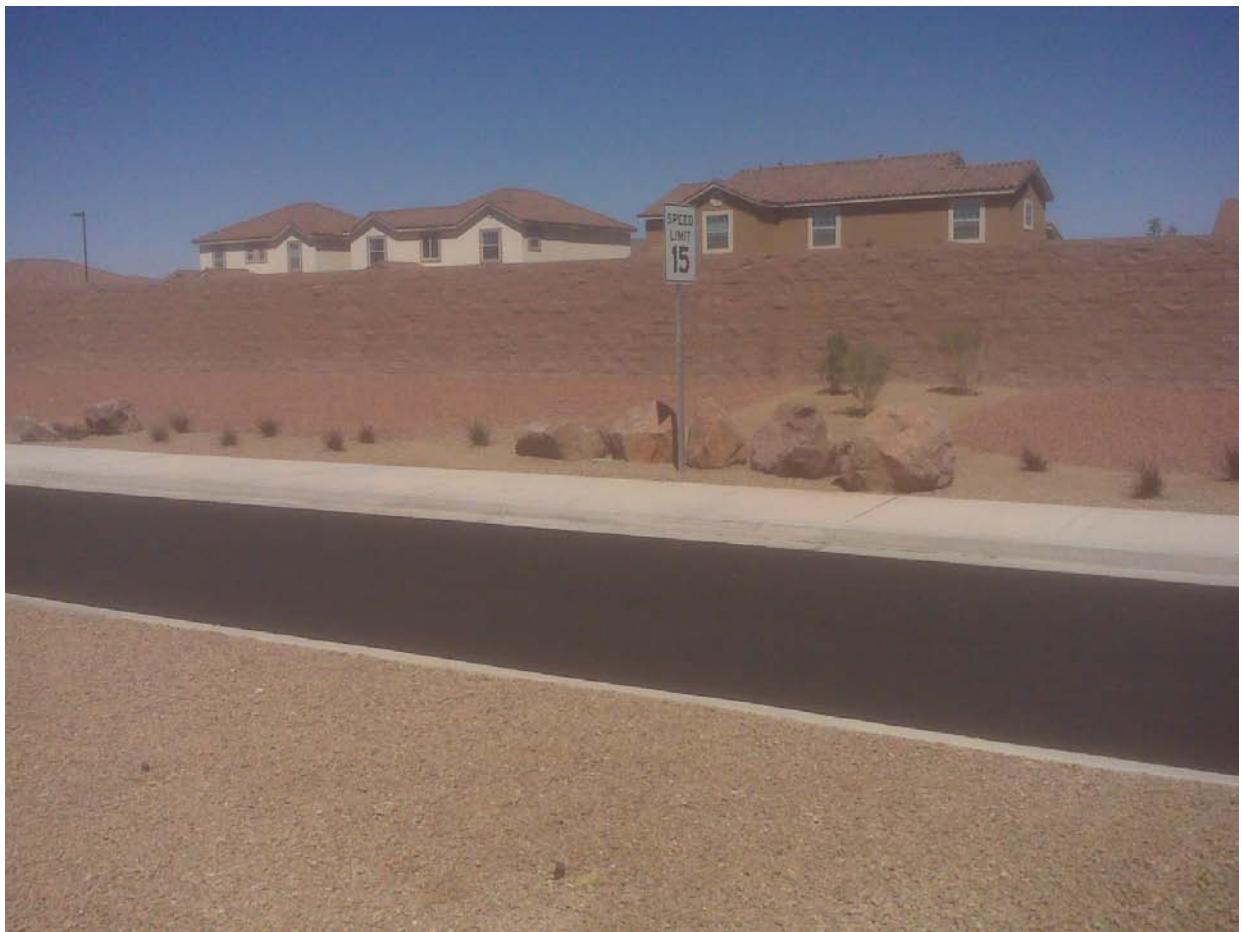
Figure 9, Parcel H west looking northeast

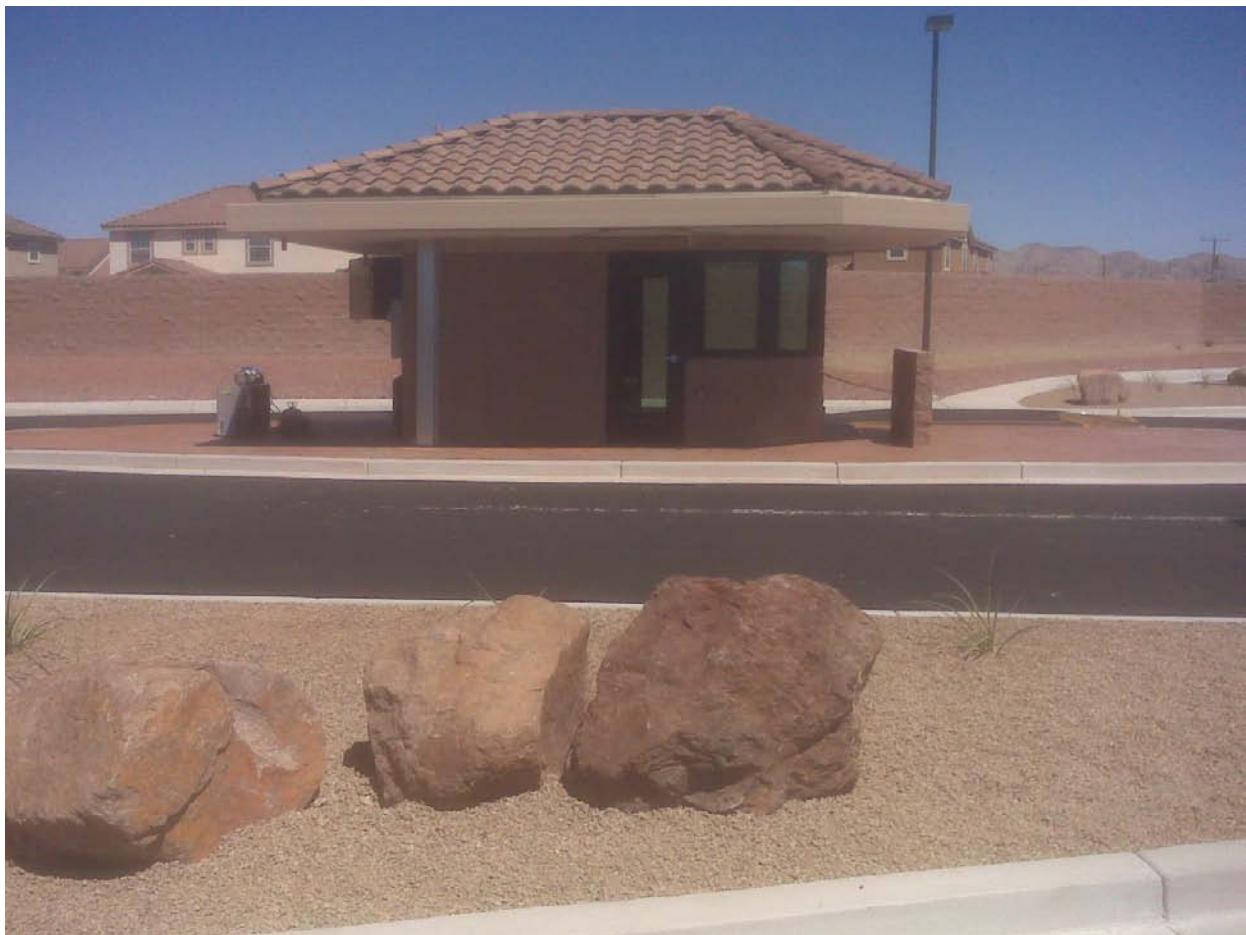
Figure 10, Parcel H west of Guard House looking east

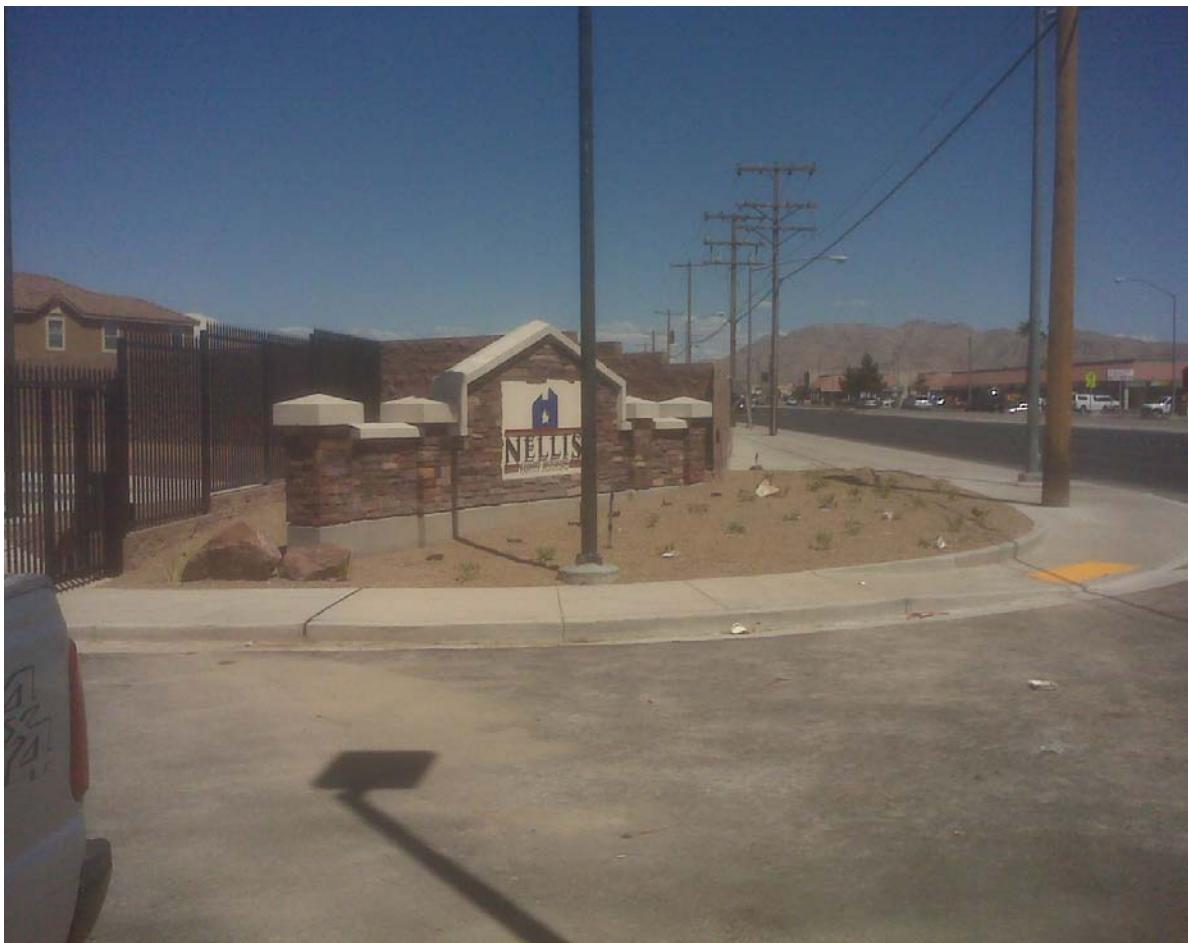
Figure 12, south boundary of Parcel H looking east
